BURTON DUENKE NO. 1 LAKE DAM

CAMDEN COUNTY, MISSOURI

MISSOURI INVENTORY NO. 31610

PHASE I INSPECTION REPORT
NATIONAL DAM SAFETY PROGRAM

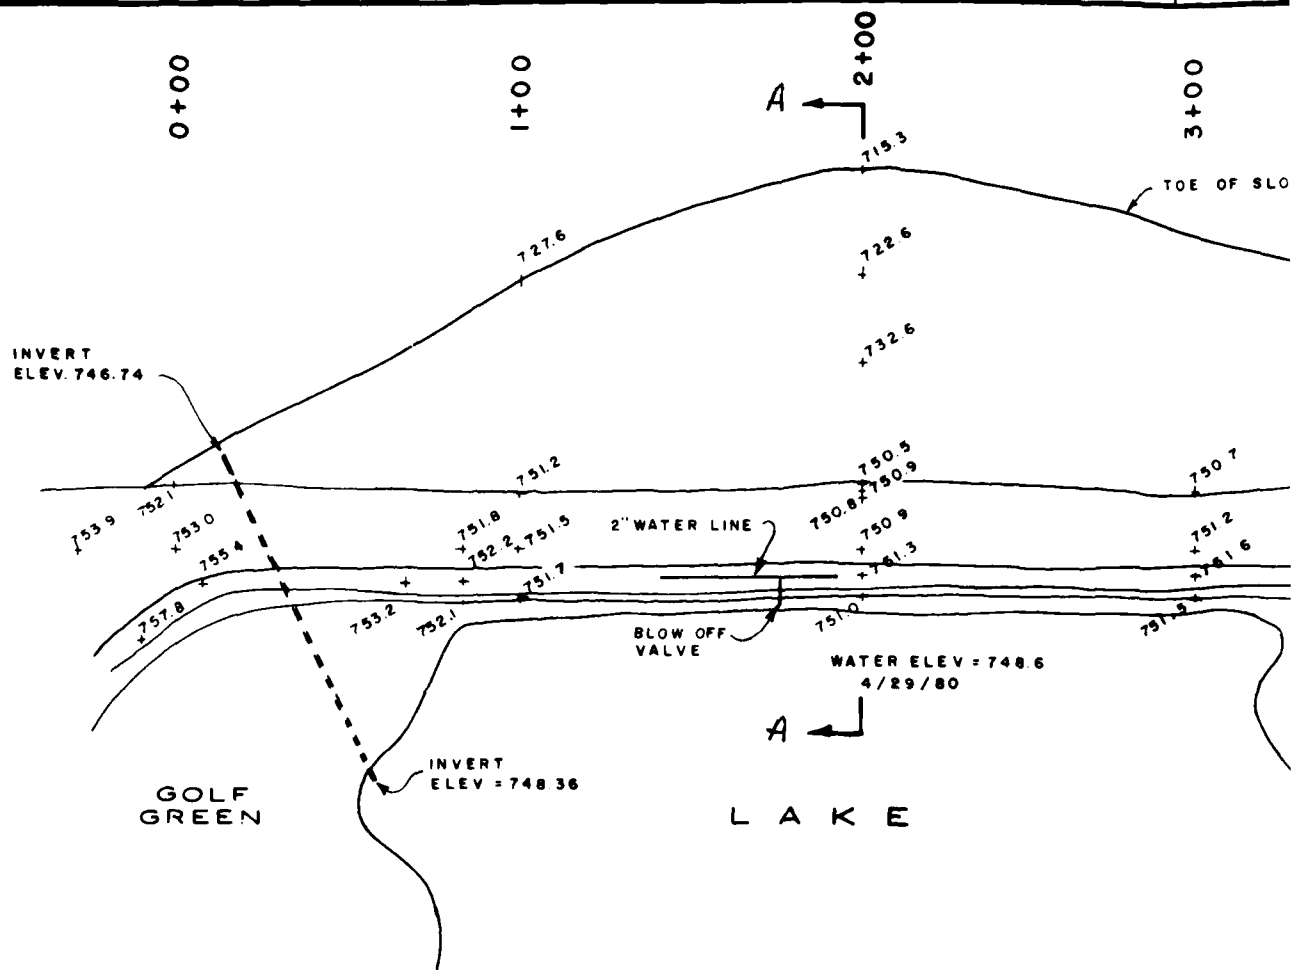
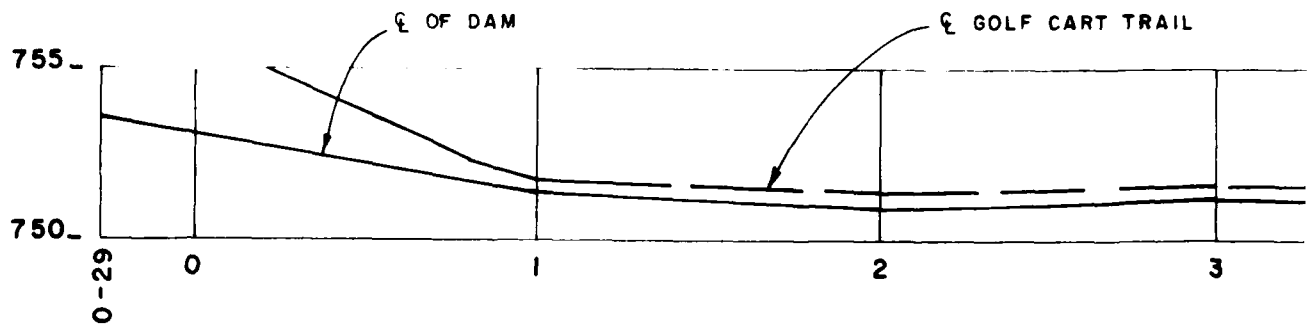
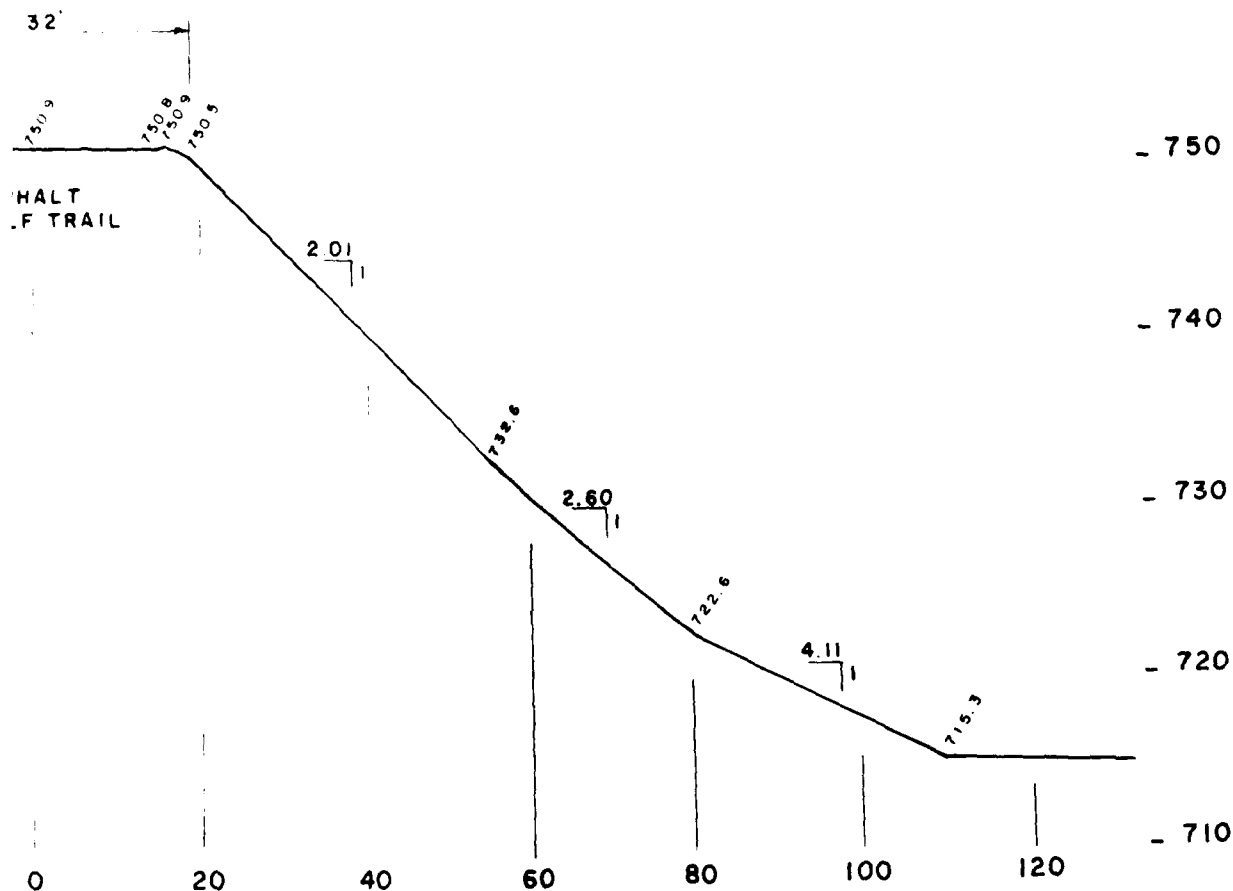
SHEET 3 APPENDIX A

Sheet 3 of Appendix A shows a plan profile and typical section of the embankments.
